Impact of the Kayelekera uranium mine, Malawi

**Based on
CRIIRAD and CFJ
May 2012 mission
in Malawi**

Bruno Chareyron, nuclear physics engineer,
head of the CRIIRAD laboratory

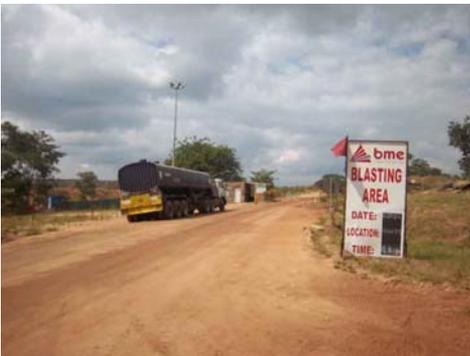
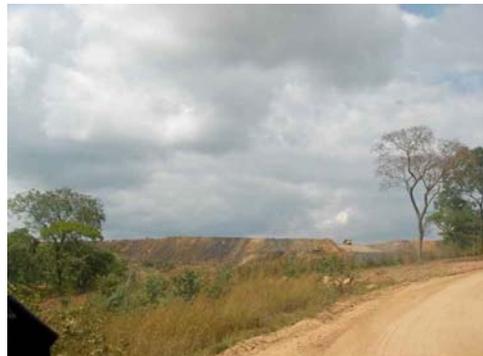
Figs. 3-4

Entrance to Paladin’s mine and view of a waste rock dump

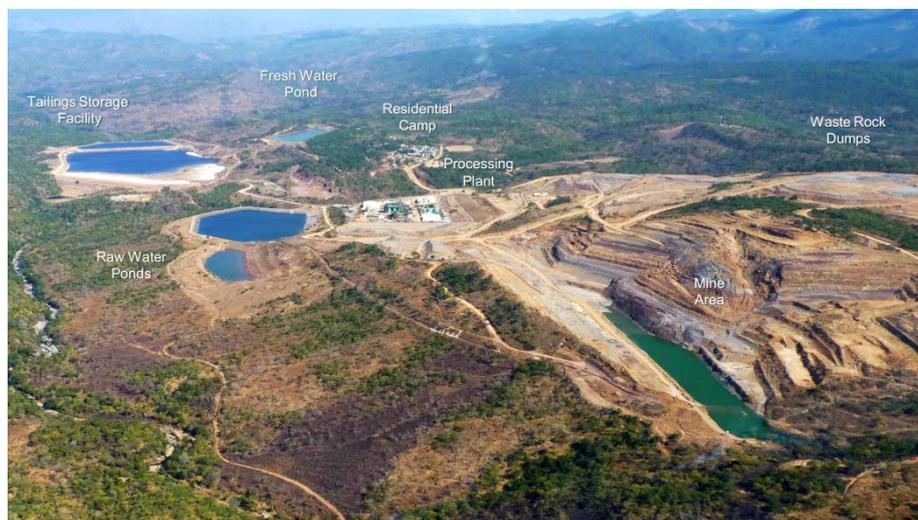
**Aerial view of the
Kayelekera uranium mine,
Tailings Storage Facility
(TSF A) and raw water
ponds**

The tailings are stored in “TSF A” located in the south-east of the mine site on the right bank of the Sere river catchment (see Fig. 6 below). According to Paladin “TSF A will fill practically the whole of the Kantchindu valley. A seepage detection dam has been built in the Kantchindu valley downstream of the main tailings dam to intercept any seepage that may leak through the basin lining and grout curtain. Any collected seepage water will be pumped back into the tailings basin” (2006 EIA report, ES-10).

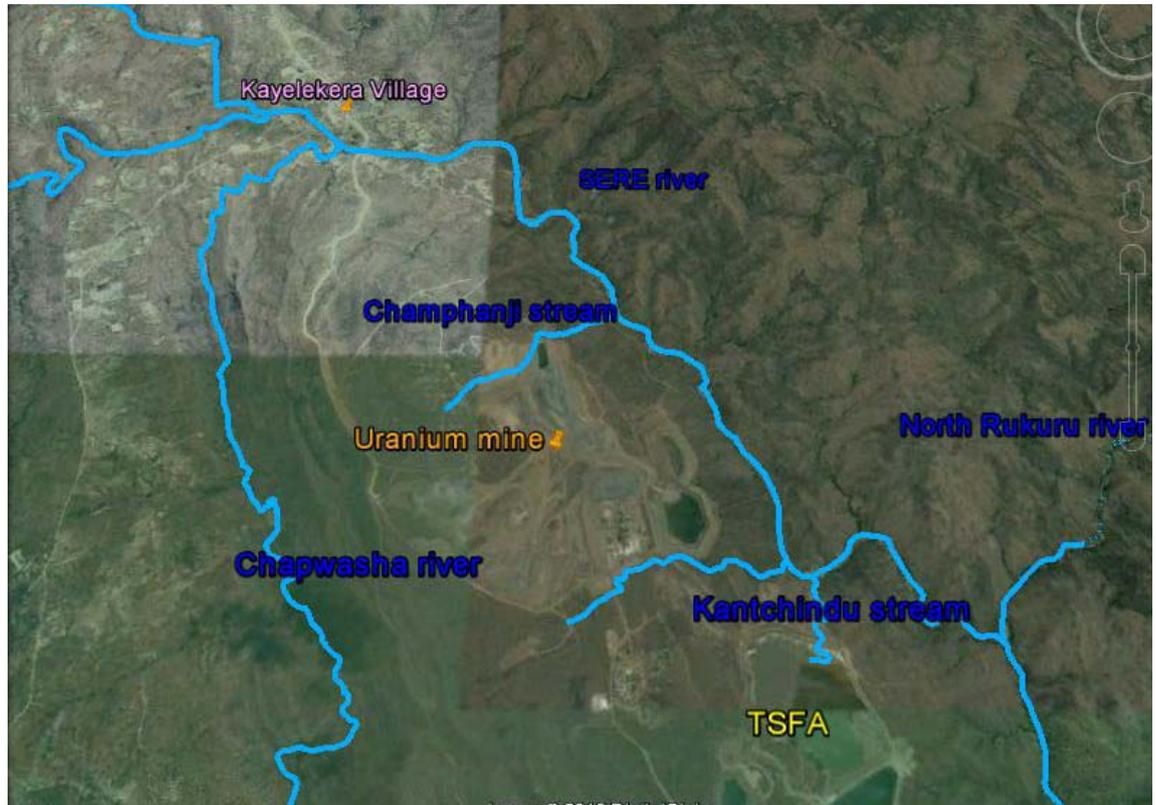
Fig. 7
Aerial view of the Kayelekera uranium mine, Tailings Storage Facility, and main rivers and streams

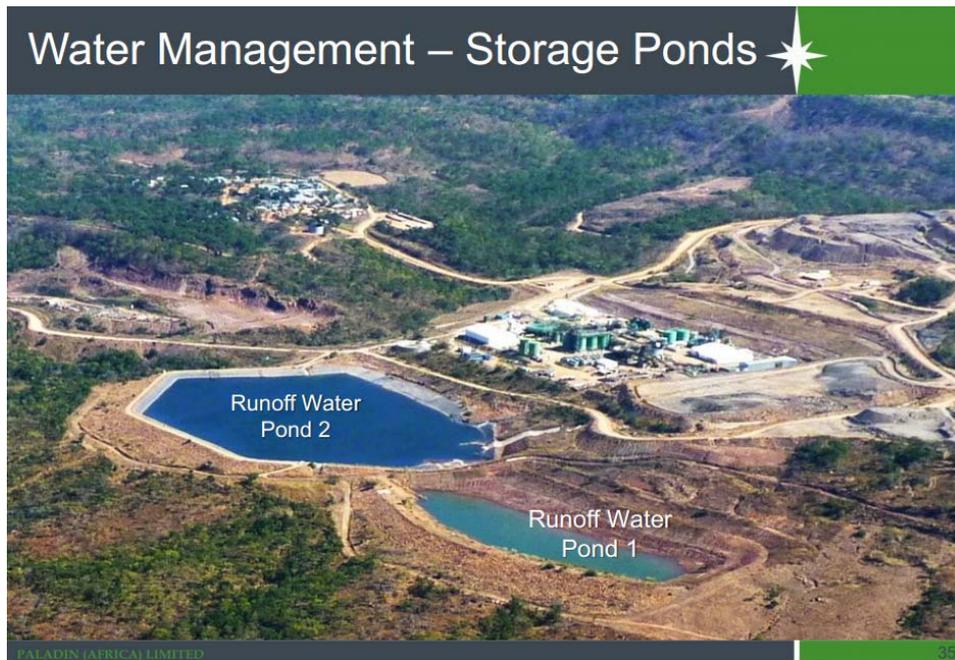
Fig. 8

Aerial view of the Kayelekera uranium mine runoff water ponds

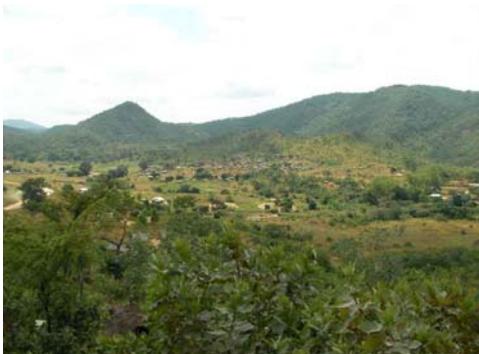
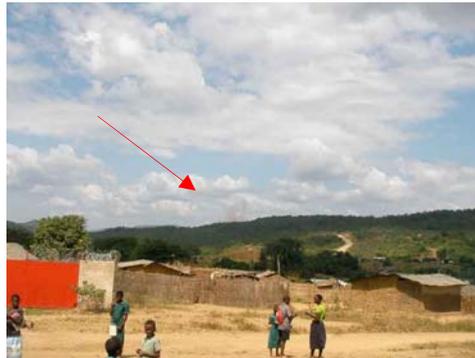
Figs. 9-10

View of Kayelekera village: picture on the left is taken from the mine area, picture on the right is taken from the village, dust from blasting at the mine is visible

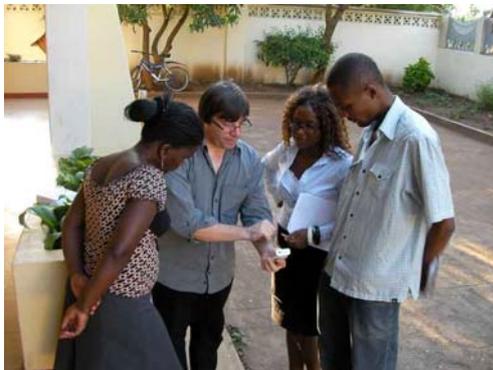
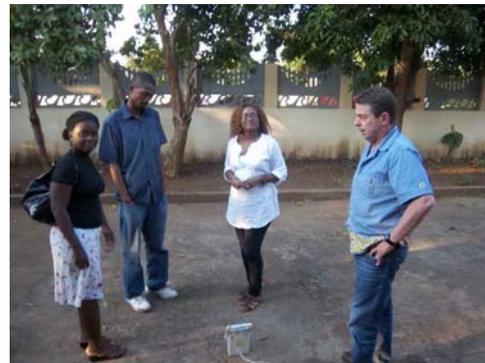
Figs. 13-14

CFJ member M. Nyirenda is sampling surface water and sediments in the North Rukuru river

- SD8: fine sediments of the North-Rukuru river collected after the confluence of the Sere river, about 12 km downstream of the mine (gamma flux of 150 c/s at the surface); see **Figs. 13-14**.

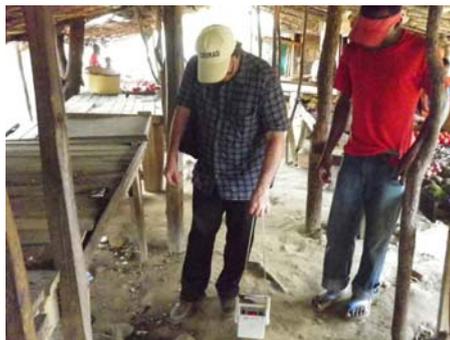
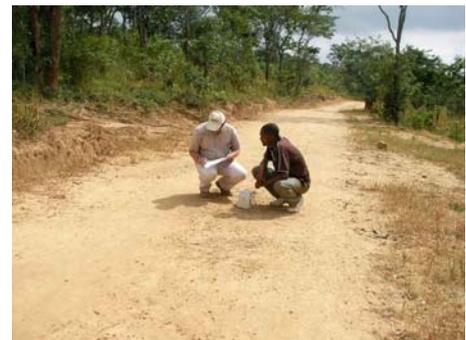
Figs. 19-20

Discussion with the chief of Kayelera village at Nkhachira (left: dry borehole ; right : presentation of a radon passive detector)

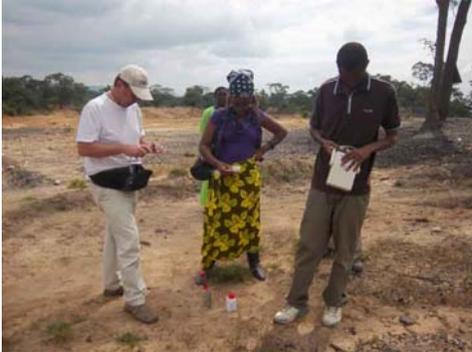
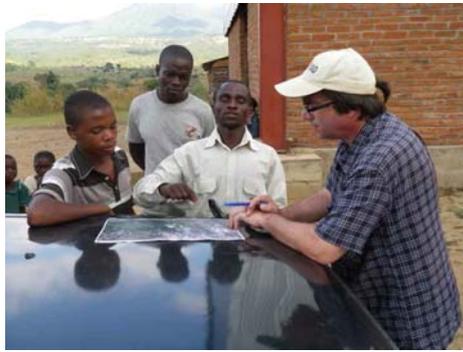
Figs. 21-22

Sampling of top soil (left) and discussion about the location of the main streams (right)

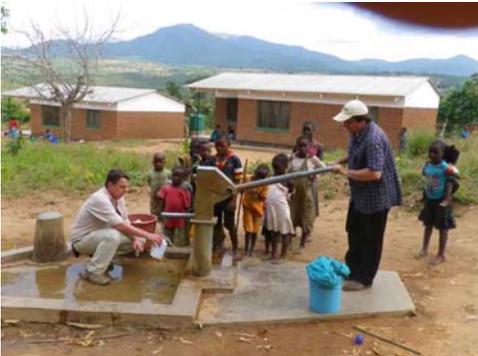
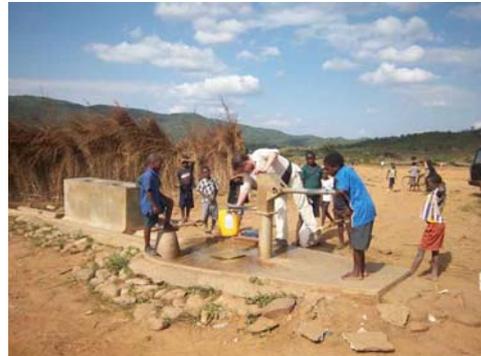
Figs. 24-25

Sampling of underground water UW1 and UW2 at Kayelekera

Another borehole that was equipped with a handpump by Paladin Africa in August 2007 has been sampled by CRIIRAD. It is located close to the football ground (sample UW2, on the right bank of the Sere River, Fig. 25). CRIIRAD has no information about the depth to groundwater.

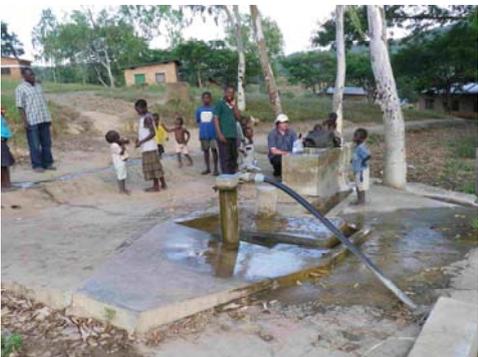
Fig. 26

Sampling of underground water UW3, artesian borehole, at Kayelekera

It should be noted that radium 226 activity mentioned in Paladin EIA (year 2006, page 6-134) was 0.52 Bq/l in the sample called "artesian borehole" which is very probably UW3 (taking into consideration the map provided in the report).

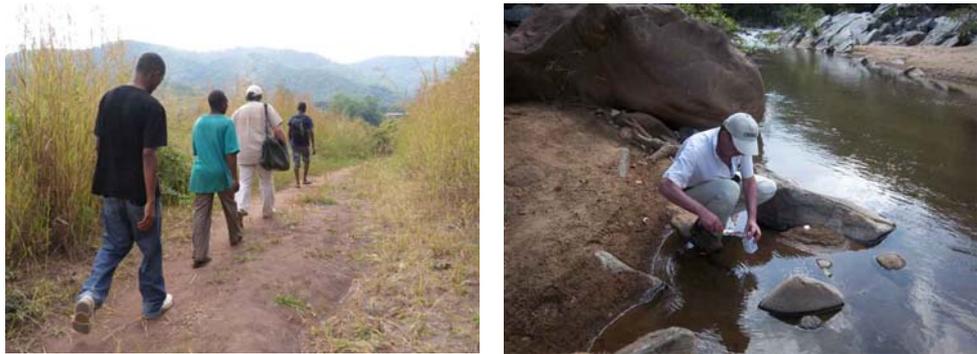
Fig. 30

Location of surface water samples / Zoom near the uranium mine

Unfortunately, due to time constraints, to the difficulty of accessing the area by walking and to the problems of localization⁹, it was not possible to reach the Kanchindu stream immediately downstream the TSF A (location SWX on Fig. 30). Water sample SW3 (Sere river) is therefore not under the influence of the TSF A but it may be impacted by leakages from the open pit and dams built to store contaminated water.

Sampling locations are plotted in **Figs. 30** and **31**.

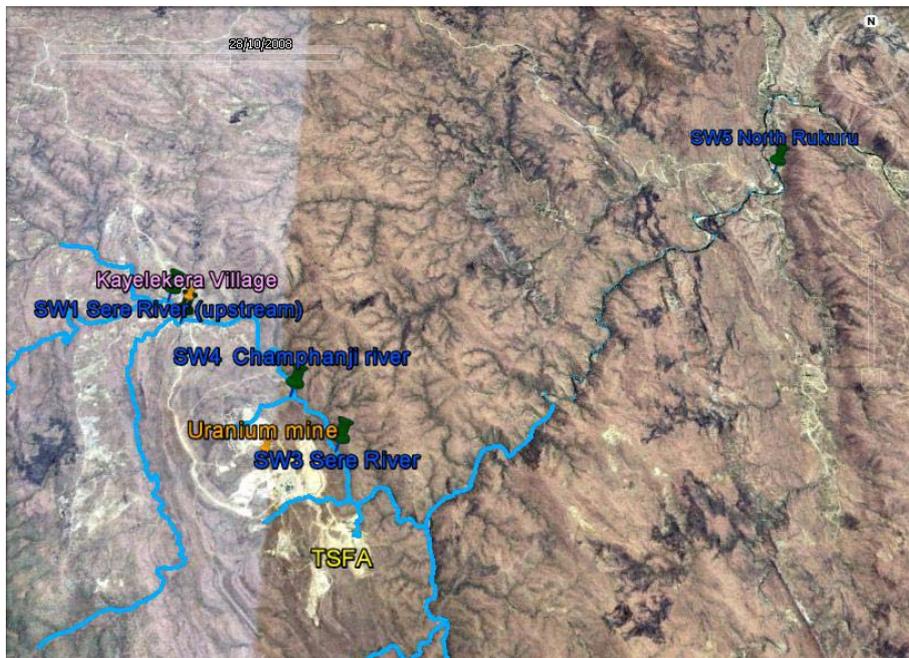
Fig. 31

General view of surface water samples, including sample SW5 (North Rukuru river downstream the confluence with the Sere river)

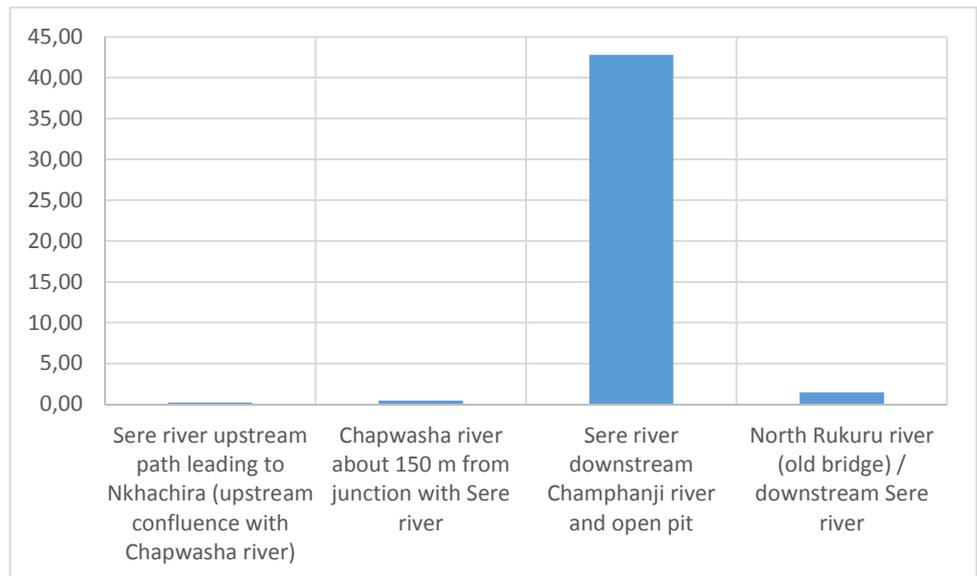
Fig. 32
Uranium concentration ($\mu\text{g/l}$) in the rivers near Kayelekera uranium mine
 Source: CRIIRAD, May 2012

But it is very high in the Champhanji stream flowing under the potential influence of the open pit (5 230 $\mu\text{g/l}$ which is equivalent to 65 Bq/l for uranium 238). For comparison, the WHO recommended limit for uranium in drinkable water is 30 $\mu\text{g/l}$. In the case of France, the discharge limit for effluents from uranium mines is 1 800 $\mu\text{g/l}$. This limit applies to the effluent prior to dilution in the river. Moreover, it is too high a limit because it was set before the establishment of the new recommendations of the International Commission on Radiological Protection (ICRP 60 in 1990).

Impact is detected in the Sere river about 1.6 km downstream the confluence with the Champhanji river (SW3 : 42.8 $\mu\text{g/l}$).

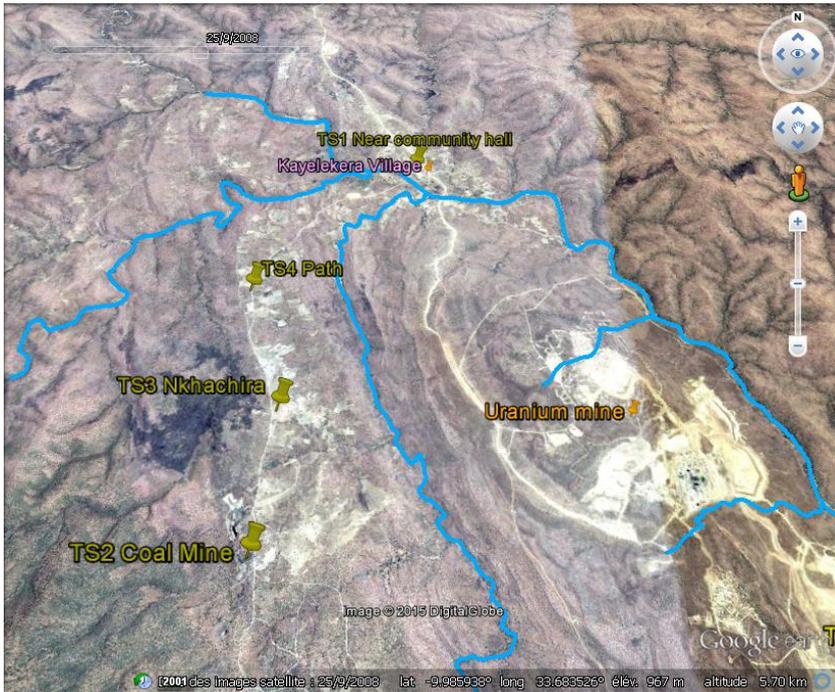
Fig. 36
Location of coal mine, uranium mine and soil samples TS1, TS2, TS3, TS4
Source: GoogleEarth, 2008

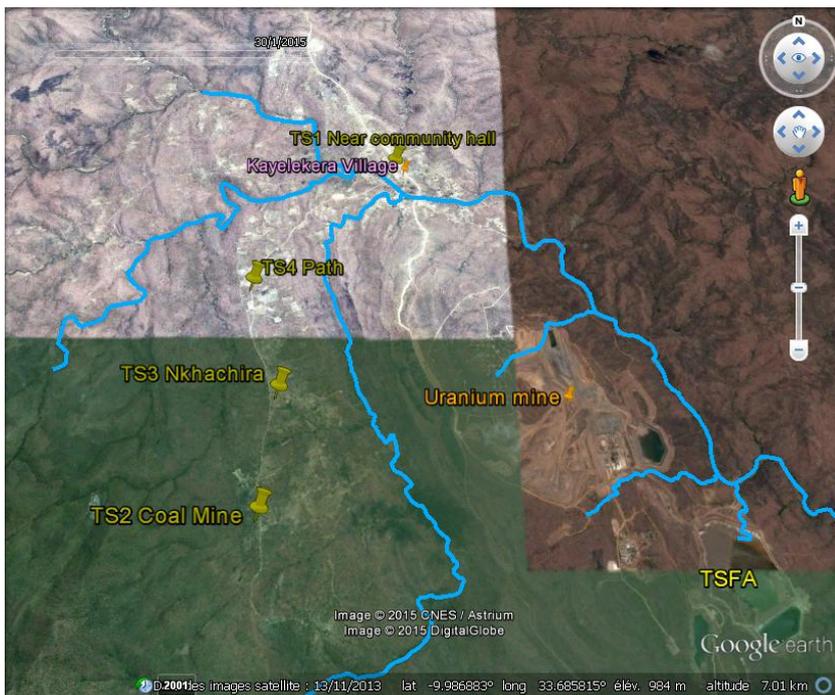
Fig. 37
Location of coal mine, uranium mine and soil samples TS1, TS2, TS3, TS4
Source: GoogleEarth, 2013

It is difficult to determine the origin of the high uranium 238 and thorium 232 activities detected in top soil samples TS2 and TS4. These values may be of natural origin and have nothing to do with the impact of the uranium mine. A more comprehensive study would be necessary to conclude.

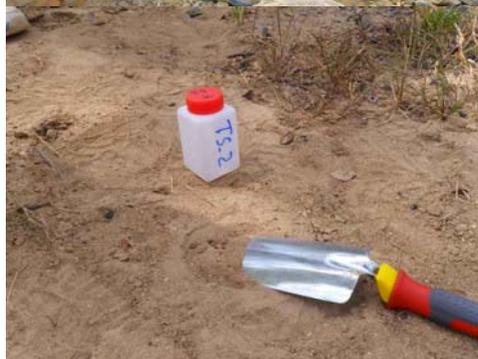
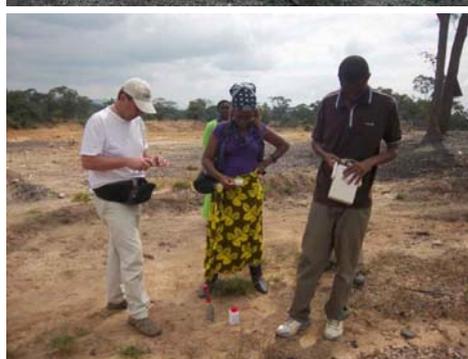
Figs. 40-41

Sampling and monitoring of gamma radiation in Nkhachira (coal mine) Sample TS2

In the sample of coal, the activities of uranium 238 (48 Bq/kg) and its decay products are comparable to the mean activity of the earth crust (40 Bq/kg). The activity of thorium 232 (44 Bq/kg) is also comparable to the mean value in the earth crust (40 Bq/kg). But, in samples TS2 and TS4, the activity of uranium 238 is higher (159 Bq/kg and 600 Bq/kg respectively). The uranium 238 / radium 226 ratio is close to one. The activity of thorium 232 is also high (430 Bq/kg and 2 160 Bq/kg respectively).

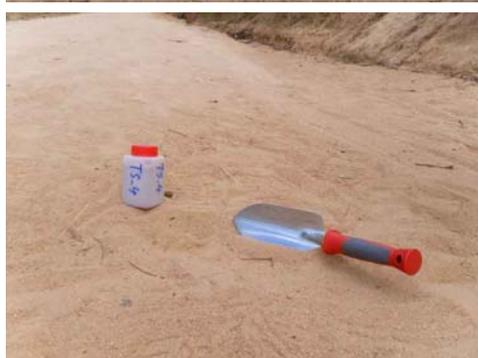
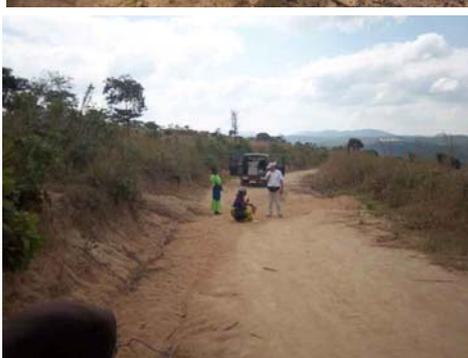
Figs. 42-43

Sampling and monitoring of gamma radiation in Nkhachira (path) Sample TS4.

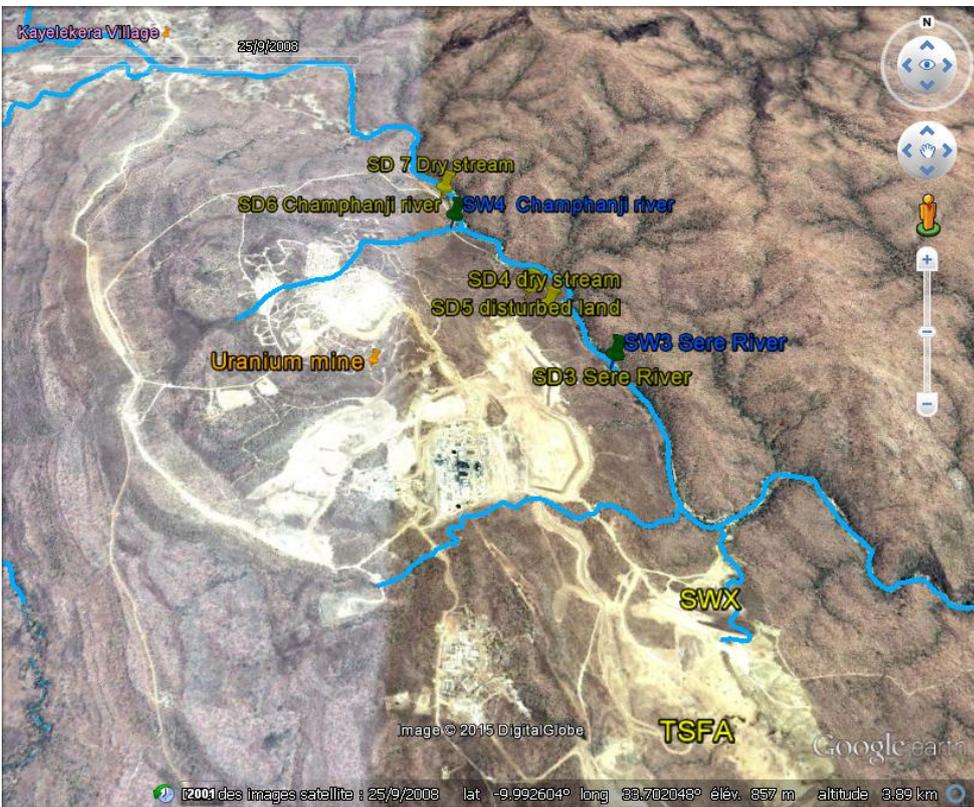
Fig. 48
Samples collected on the eastern slope of the uranium mine (2008 satellite image)
Source: GoogleEarth-CRIIRAD

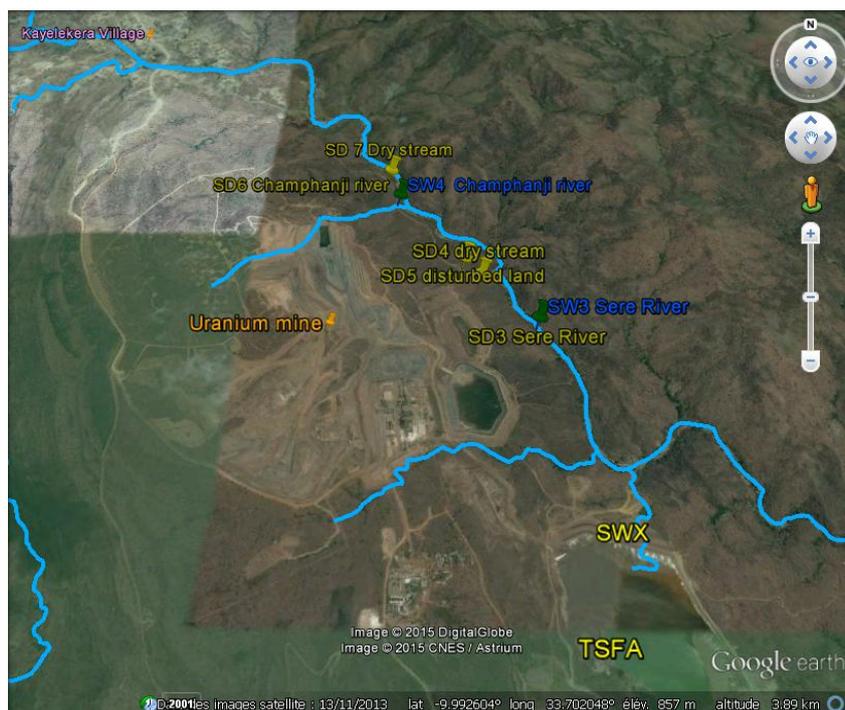
Fig. 49

Samples collected on the eastern slope of the uranium mine (2013 satellite image)

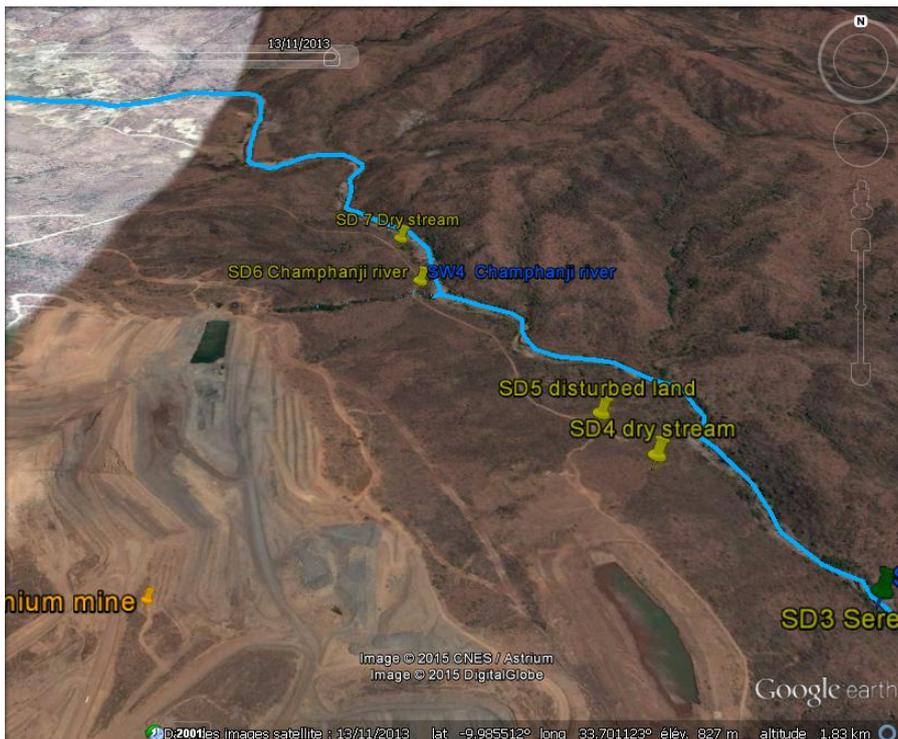
Fig. 50

Samples collected on the eastern slope of the uranium mine (2013 satellite image), zoom

But another hypothesis, is that Paladin may have conducted drilling activities there during uranium prospection campaigns.

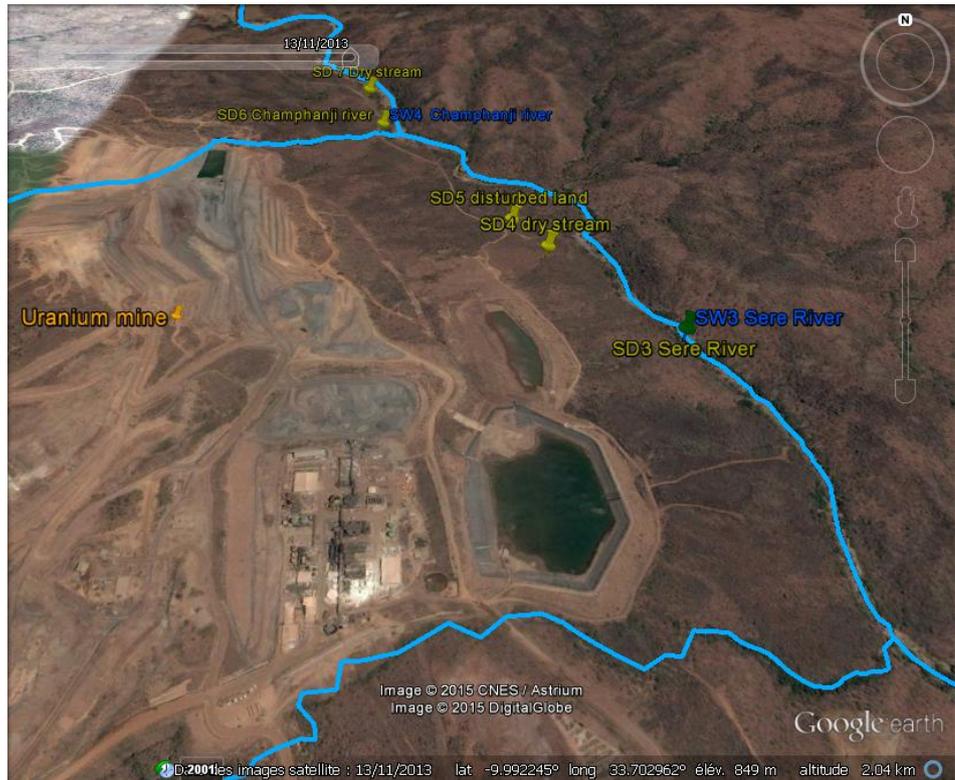
Fig. 52

Sample SD5 (disturbed land) collected on the eastern slope of the uranium mine (September 2008 satellite image) / No perturbation is seen on the picture.

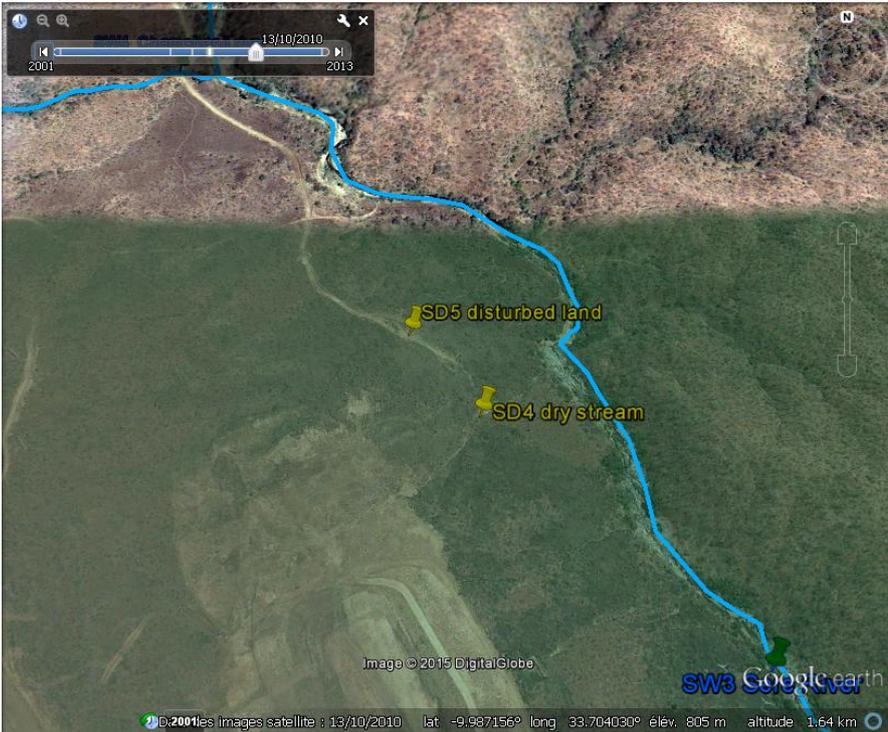
Fig. 53

Sample SD5 (disturbed land) collected on the eastern slope of the uranium mine (October 2010 satellite image) / soil perturbation is seen on the picture, no water in the reservoir

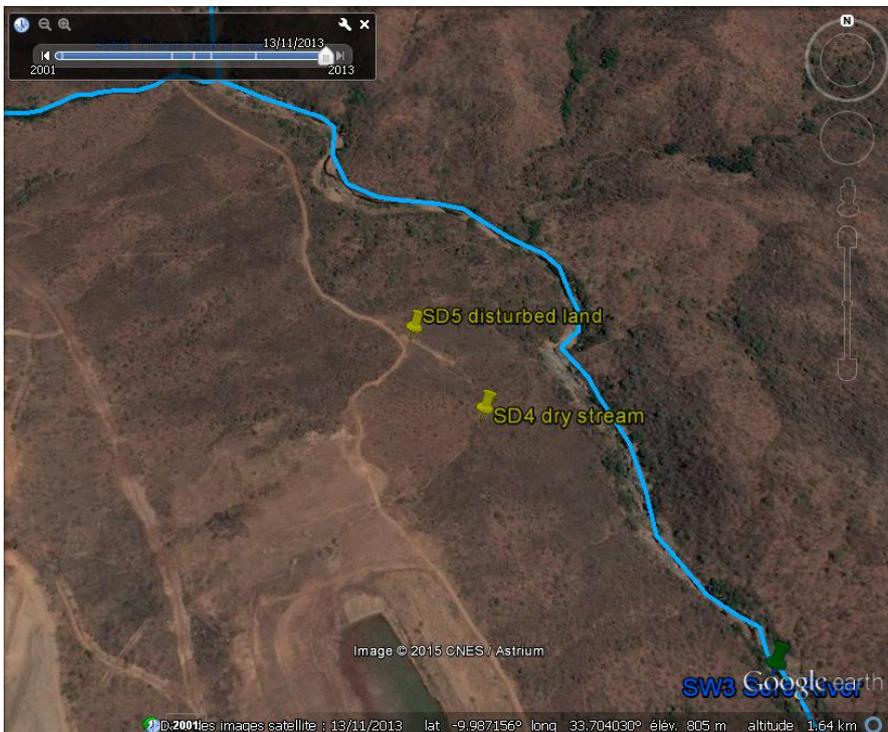
Fig. 54

Sample SD5 (disturbed land) collected on the eastern slope of the uranium mine (November 2013 satellite image) / soil perturbation is seen on the picture, water is seen in the reservoir

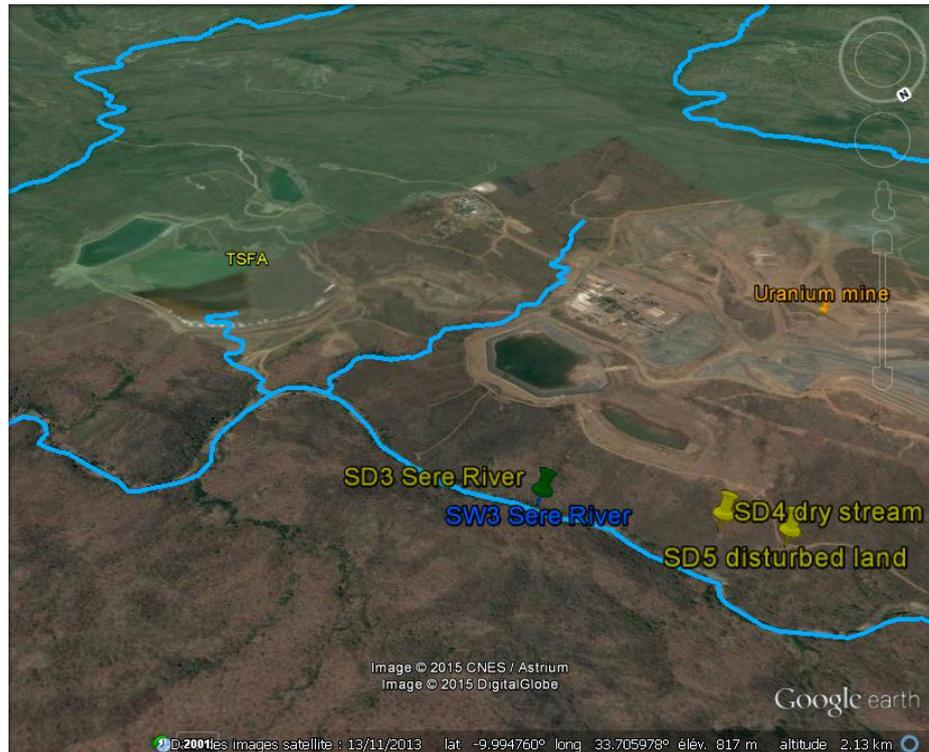
View of the mine, raw water dams and TSF (November 2013 satellite image)

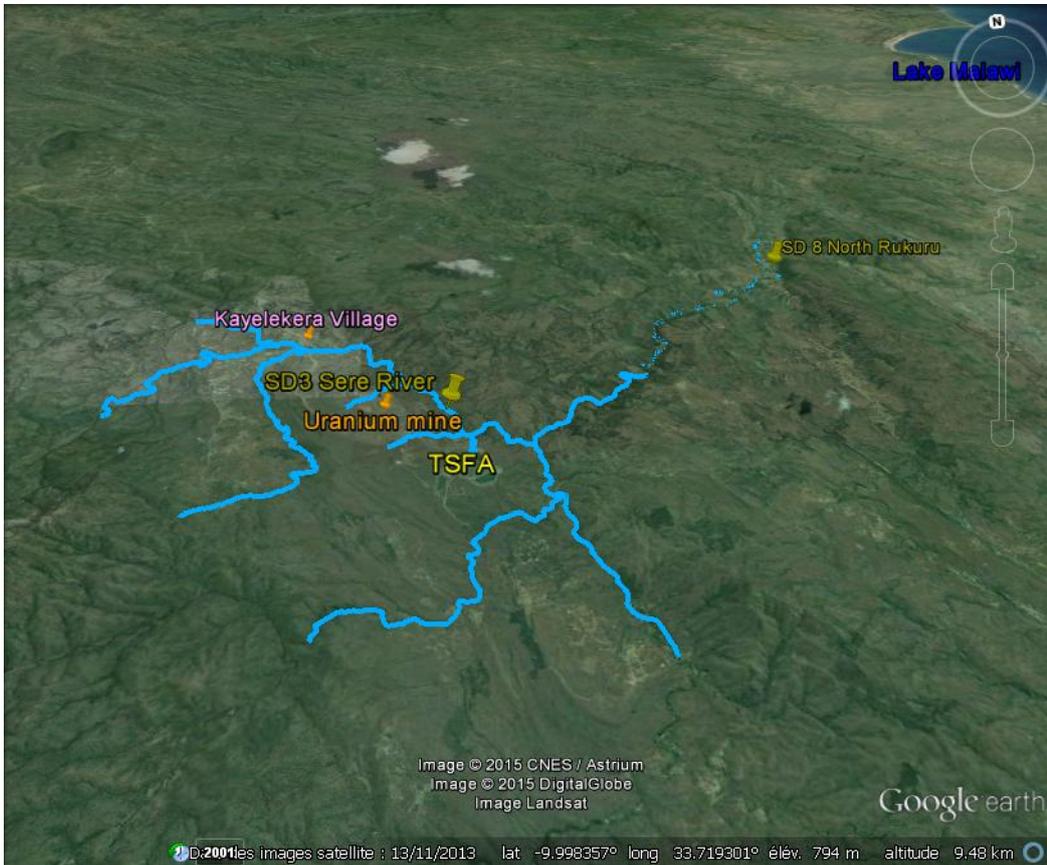
Fig. 56

Location of sediment samples SD3 and SD8 (November 2013 satellite image) / lake Malawi appears on the right corner.

Sampling locations of sediments SD3 and SD8 are plotted in **Fig. 56** below.
